RE: Report of Collision Investigation and Reconstruction

Pursuant to your request, Insight-Forensics has investigated a motor vehicle-bicycle collision that resulted in the death of [REDACTED], on August 21, [REDACTED]. The accident occurred in [REDACTED] Alaska, in the driveway of [REDACTED] gas station/convenience store ([REDACTED]) addressed at [REDACTED] Road, just north of a roundabout and the [REDACTED] Highway. Our understanding is that on the afternoon of August 21, [REDACTED], bicyclist [REDACTED] was riding home from school on the sidewalk adjacent to [REDACTED] Road. At the same time, [REDACTED] was driving a commercial flatbed work truck along [REDACTED] Road in the same direction as the bicyclist. The two collided at the sidewalk crossing of the driveway to the [REDACTED] at 2:52 pm. [REDACTED] was reportedly killed when he rolled under the truck and rear double axles of the flatbed. The purpose of this report is to present a detailed accident reconstruction and analysis, and provide an expert opinion as to the cause(s) of the collision. Dr. Dennis Filler, Professional Engineer, and Dr. Mike Donaldson, Senior Scientist performed the investigation, collision reconstruc

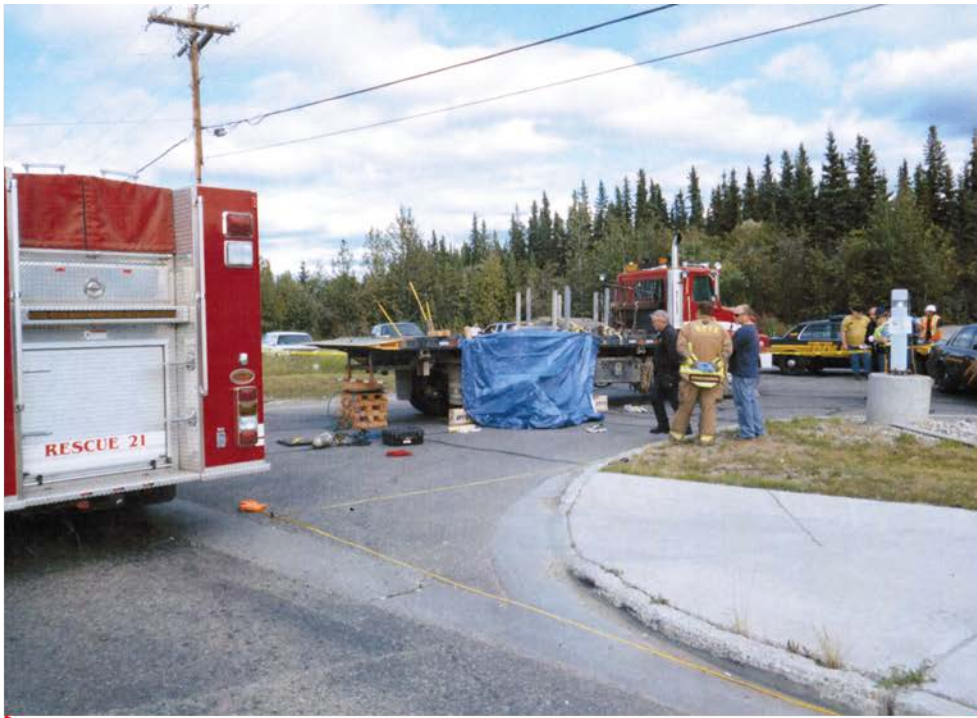
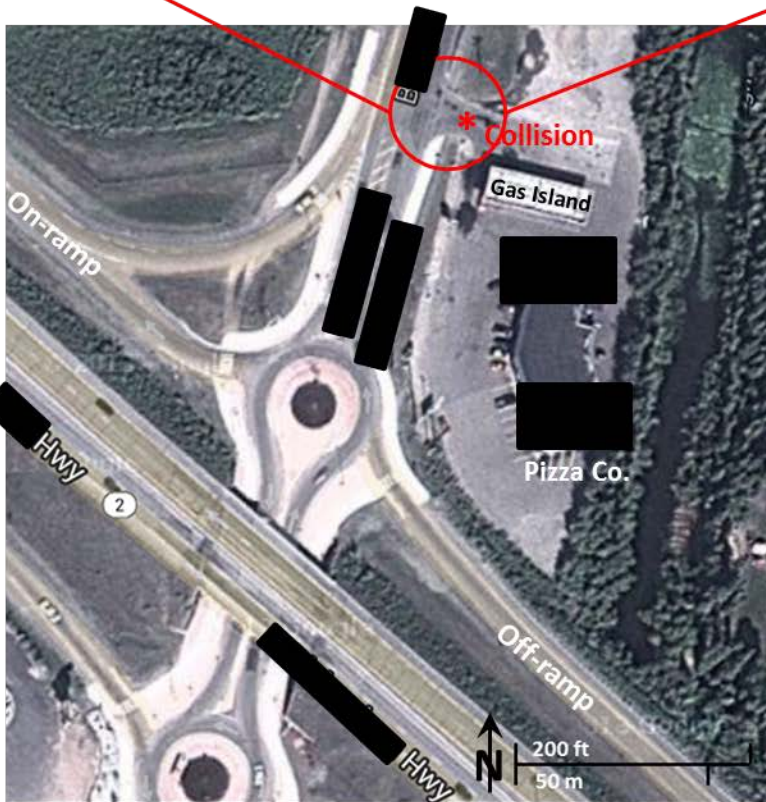
Figure 1. Accident scene. The bottom image is a Google base map depicting the collision location at the intersection of [redacted] Road and [redacted] driveway. The top accident-scene photograph shows the final resting position of the [redacted] truck after collision.

The collision scene was the driveway entrance to a small commercial plaza (Fig. 1). [REDACTED] gas station and convenience store and a [REDACTED] Company outlet are the primary tenants of the plaza. According to the [REDACTED] surveillance video of the accident, both the [REDACTED] truck and bicyclist were traveling northbound along [REDACTED] Road. The truck was in the outer (or easternmost) lane and the bicyclist was traveling on the adjacent sidewalk. Eighteen inches of concrete curb and gutter separate the road from the sidewalk, and the sidewalk is 7.5 feet wide. Mr. [REDACTED] was riding a black multi-speed bike, and was wearing his helmet and small backpack at the time of collision. According to the police survey and accident scene photographs, the truck, which was turning into the [REDACTED] driveway, came to a stop in the middle of the driveway (Fig. 2) approximately 25 feet beyond the point of impact with the bicyclist (Fig. 1).

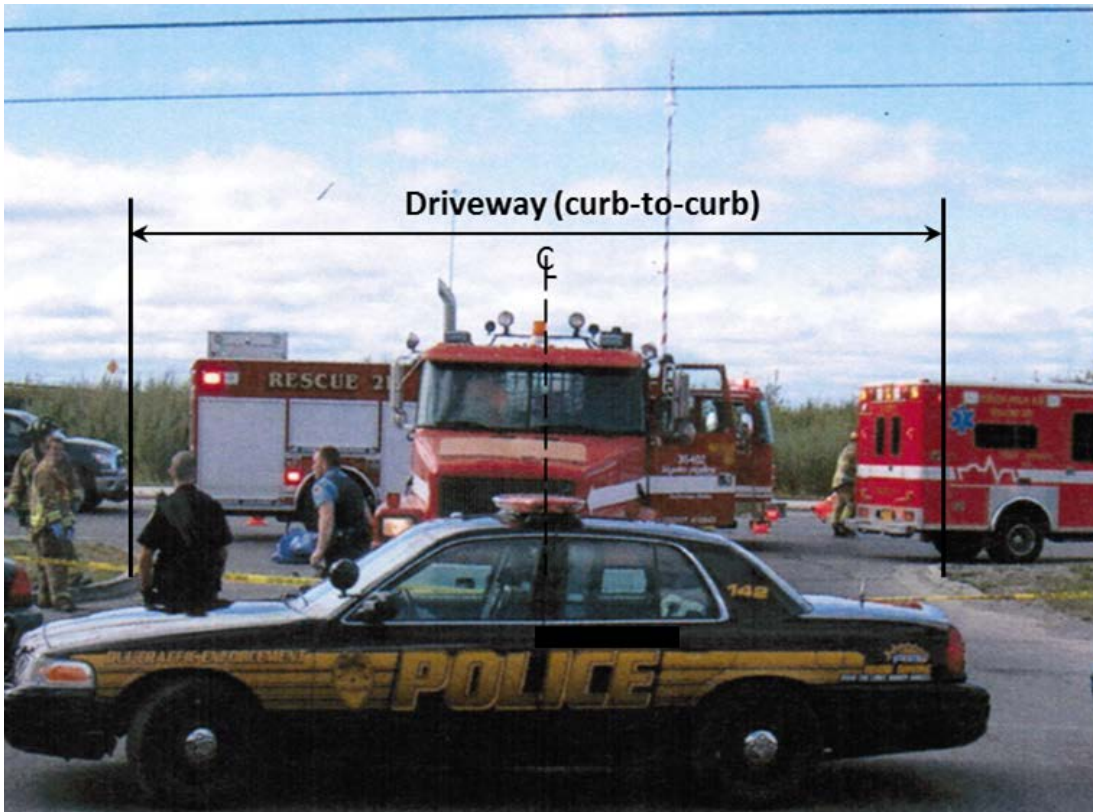
Figure 2. The final resting position of the [redacted] truck at the accident scene on August 21, [redacted]; truck is centered in the [redacted] driveway.

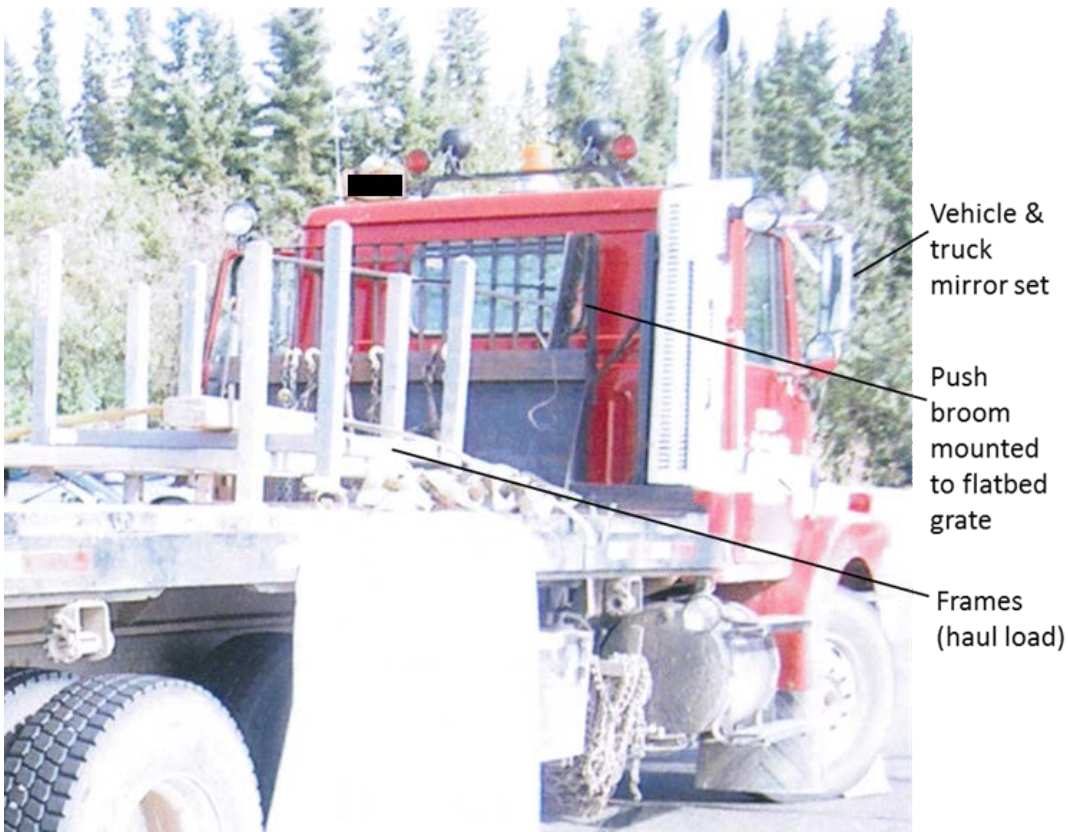
Figure 3. [redacted] truck features at the time of accident.

According to accident scene photographs, the commercial flatbed was a red 1993 GMC [REDACTED] Company truck with identification number 35402 (USDOT # [REDACTED]), VIN number [REDACTED], Tab # [REDACTED], and license plate [REDACTED]. The truck had three axles, one in the front and a dual-axle, dual-wheel configuration under the rear of the flatbed. This 10-wheel truck was equipped with vertical and convex round, over-and-under, vehicle and truck mirror sets on both sides of the cab (Fig. 3). The mirrors were later identified as Prutsmen 7"x 16" West Coast Style mirrors above Mirrex convex round mirrors; the driver's side round was 8.25 inches in diameter and the passenger-side round was 7.5 inches across. At the time of the accident, a push broom was strapped across the flatbed grate behind the cab rear window, and metal frames were strapped to the flatbed (Fig. 3).

We considered the possibility that [REDACTED] failure to yield was due to the biker being obscured from his view in some way. The alternative was that [REDACTED] was visible, but [REDACTED] failed to notice him. To test this hypothesis we accessed the truck at the [REDACTED] Yard on September 30, [REDACTED]. We took measurements and photographs of the [REDACTED] truck, noting that although the truck had been repainted white and renumbered (36225), its USDOT and VIN identification numbers confirmed it was the same truck. We also confirmed that the cab side mirrors matched those that were on the truck at the time of collision (Fig.3).

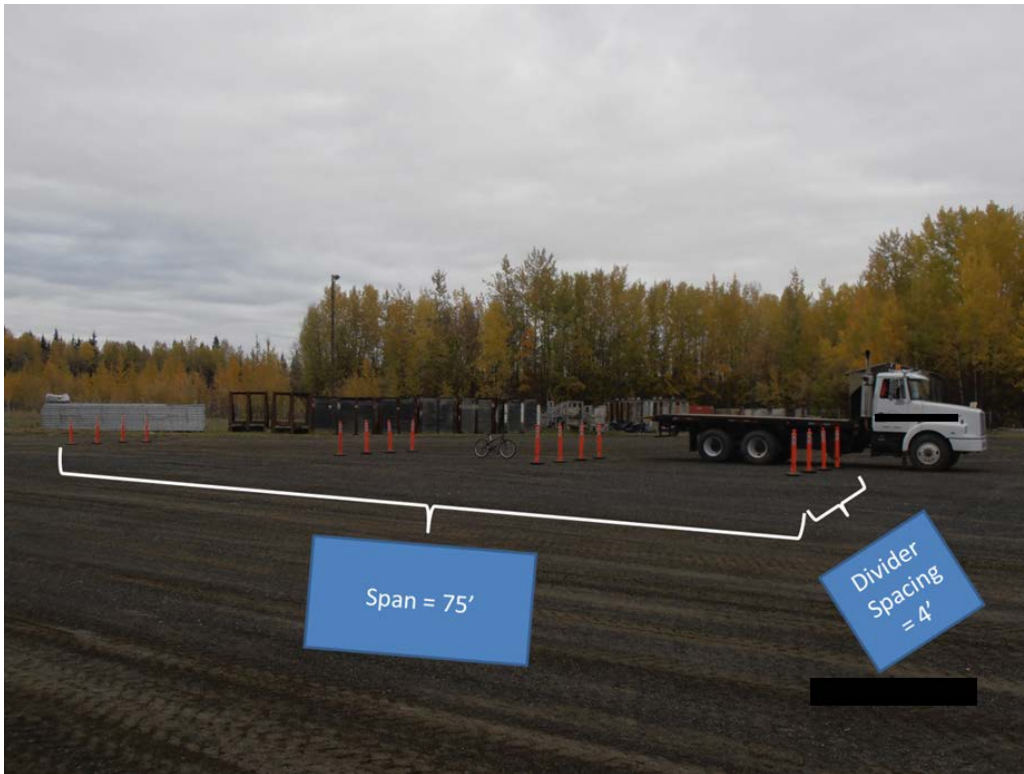
Figure 5. Mirror analysis: field simulation setup to determine mirror fields of view.

Fields of view of the passenger side west coast vertical and convex (spot) mirrors were measured by laying out a pattern of traffic dividers spaced evenly apart in four rows of four cones each to form a 12 x75 foot grid along the passenger side of the truck (Fig. 5). The first row of the grid was placed at the most forward point visible in the spot mirror field of view. We quantified fields of view by positioning the camera at eye level in the driver's position, and determined which traffic dividers were visible in each mirror. We also observed the effect of varying the position of the camera on the resulting field of view in each mirror. We found that the view in the spot mirror is insensitive to driver position, whereas the narrow west coast field of view will shift left or right by approximately 5 degrees, depending on driver head position. Spot and west coast mirror fields of view are depicted in Figure 6.

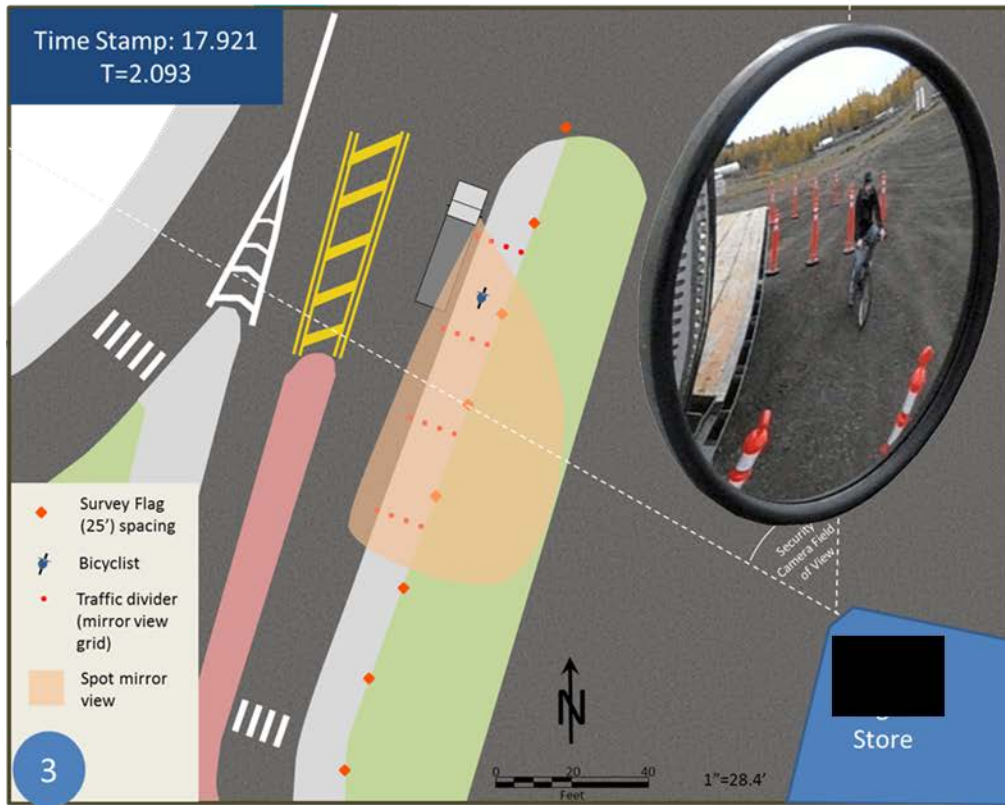
Figure 7b. Reconstruction sequence correlated with truck spot mirror visibility simulation. Frame 3: Truck and bicyclist approaching driveway; bicyclist approximately 35 feet from driveway. Frame 4: Truck turning at driveway as bicyclist about to leave sidewalk. Note bicyclist is visible in truck mirror through entire sequence.

We combined the results from the mirror analysis with reconstruction analysis based on the real-time positions of the truck and bicycle in the surveillance video to produce the two-dimensional (2D) reconstruction sequence shown in Figures 7a and 7b. Frames 2 through 4 are accurate depictions of relative positions of the truck and bicycle transposed from the surveillance video measurements. Mirror views collected from the approach simulation experiment show bicyclist visibility through the approach sequence. Frame 1, which correlates the surveillance video with 2D reconstruction at the point the truck entered the camera field of view, shows the most likely position of the bicyclist at about 20 feet away.

To summarize, all evidence indicates that the bicyclist was never in a blind spot as the truck approached the driveway turn. In fact, the evidence from spot-mirror analysis and bicycle sidewalk simulation indicates that the bicycle would have been clearly visible in the spot mirror the entire time the truck was in the field of view of the [REDACTED] surveillance camera. This time frame coincides with when the driver would normally have been looking for pedestrians or bicyclists on the sidewalk in preparation for the turn. Further, reconstruction analysis indicates that the bicyclist would be visible in the spot mirror to at least 75 feet behind the truck's spot mirror at any time on the straightaway, and the only time the bicyclist would have left the spot mirror field of view is when he was even with the front of the flatbed of the truck, when the truck was fully committed to the turn. This evidence suggests driver inattention was a factor in the collision.

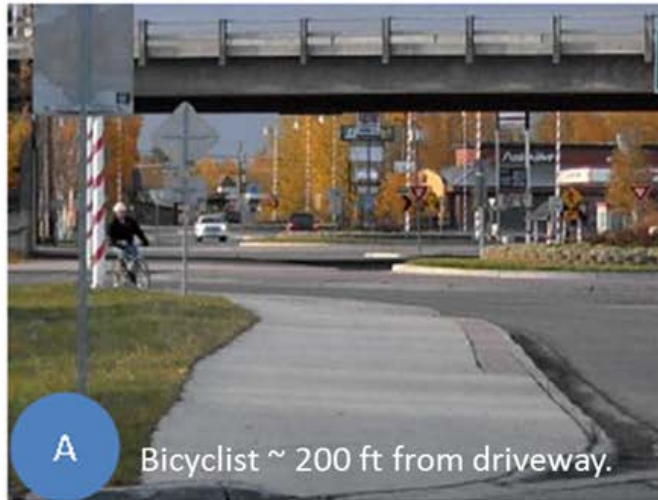
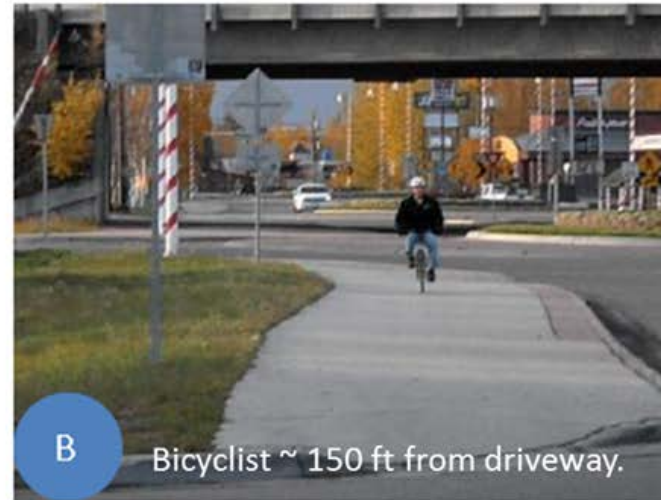
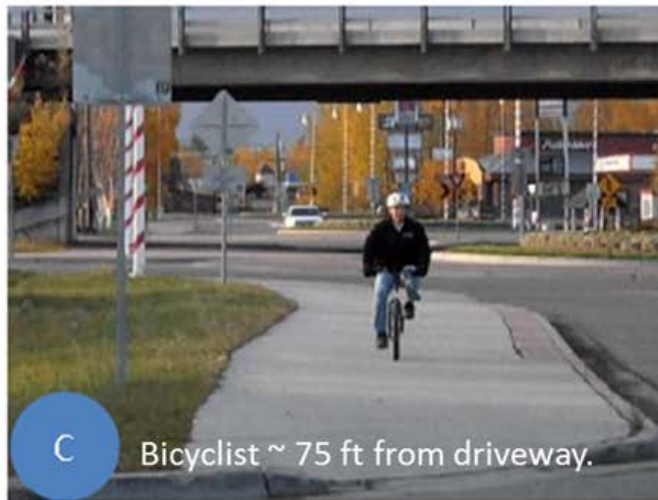
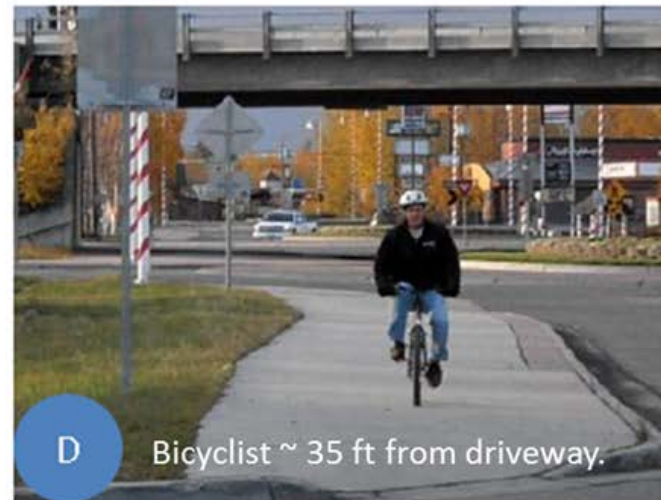
Figure 8. Bicycle simulation illustrating the visibility of a bicyclist on the [redacted] Road east sidewalk upon approach to the [redacted] driveway on a clear day.

We also tested the hypothesis that obstructions or other complicating factors at the scene in some way may have obscured [REDACTED] from [REDACTED] view. The sidewalk bicycle simulation verified the openness of the sidewalk approach, free of obstructions to visibility, such that a pedestrian or bicyclist would be clearly visible along the 168 foot stretch of sidewalk leading up to the driveway entrance (Fig. 8).

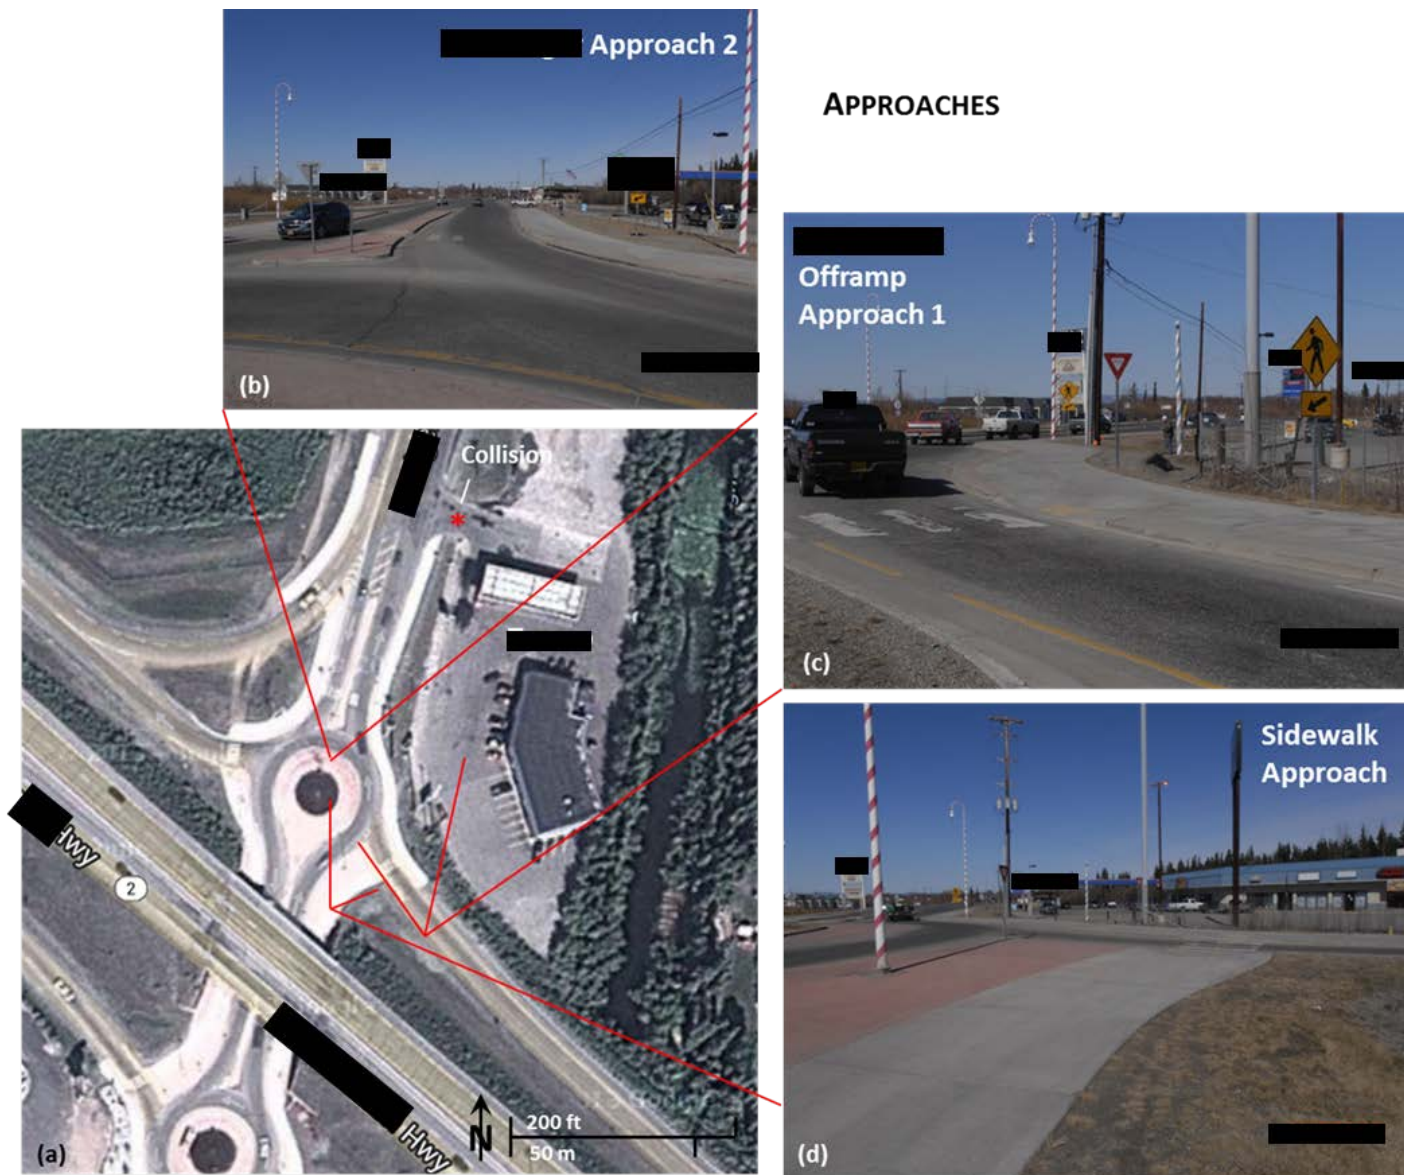
Figure 9. (a) Google base map depicting approaches to the north [redacted] Road roundabout and [redacted]; (b) and (c) depict the two possible truck approaches, and (d) the bicycle approach.

Since both truck and bicycle approached the [REDACTED] driveway from [REDACTED] Road at south, only approaches from that direction need to be considered. Bicyclist [REDACTED] was on the east sidewalk of [REDACTED] Road, and was coming from school according to eyewitness accounts. Therefore, his approach was from the [REDACTED] Road roundabouts under the [REDACTED] Highway (Fig. 9d). The [REDACTED] truck had two possible approaches: (1) the [REDACTED] off-ramp or (2) the same [REDACTED] Road roundabouts approach as the bicyclist. These approaches are depicted in Figure 9a and 9c.

If the [REDACTED] truck approached from the roundabouts (Fig. 9a, [REDACTED] Approach 2) then driver [REDACTED] should have seen the bicyclist in his front window before reaching the north roundabout. We know this because had the bicyclist been behind the truck as it approached the north roundabout, he could not have caught the truck as traffic ahead of the truck was light and not slowing according to the [REDACTED] surveillance video. Further, the bicyclist would have had to slow down through the off-ramp crosswalk to negotiate the sharp 110-degree turn-to-sidewalk transition (Fig. 10d) while the truck accelerated through the north roundabout and into the straightaway.

Now consider a truck approach from the [REDACTED] Highway off-ramp (Fig 9c). With the truck approaching the crosswalk, there are three possible bicycle positions: either the bicyclist was coming from the left and not yet into the crosswalk ahead, or he was in the crosswalk, or he was through the crosswalk and on the sidewalk to the driver's right. If the first, and the bicyclist not yet in view (i.e., under or before the [REDACTED] overpass), then the bicyclist could not have caught the truck before the [REDACTED] driveway as vehicular traffic was not congested. With the bicyclist through the underpass, and the truck driver looking left for oncoming traffic (roundabout traffic only comes from the left), he would have seen the bicyclist approaching the crosswalk. For the bicyclist in the crosswalk scenario, Mr. [REDACTED] would have first seen Mr. [REDACTED] there through the truck's front windshield. This leaves the third and most likely scenario, the bicyclist having already cleared the off-ramp crosswalk. Referring to Figure 11, with the bicyclist slowed by the crosswalk-to-sidewalk sharp-turn transition (point A), the truck would have passed the bicycle as it drove through the roundabout and accelerated upon entering the [REDACTED] Road straightaway (point B). As the bicyclist also accelerated from the crosswalk and increased his speed from 8 mph (at point A) to 21 mph (at point C), he caught the truck (traveling at 13 mph) as the two entered into the [REDACTED] surveillance camera field of view, approximately 75 feet before the driveway. Regardless of truck approach, the truck driver should have first seen the bicyclist at the roundabout.

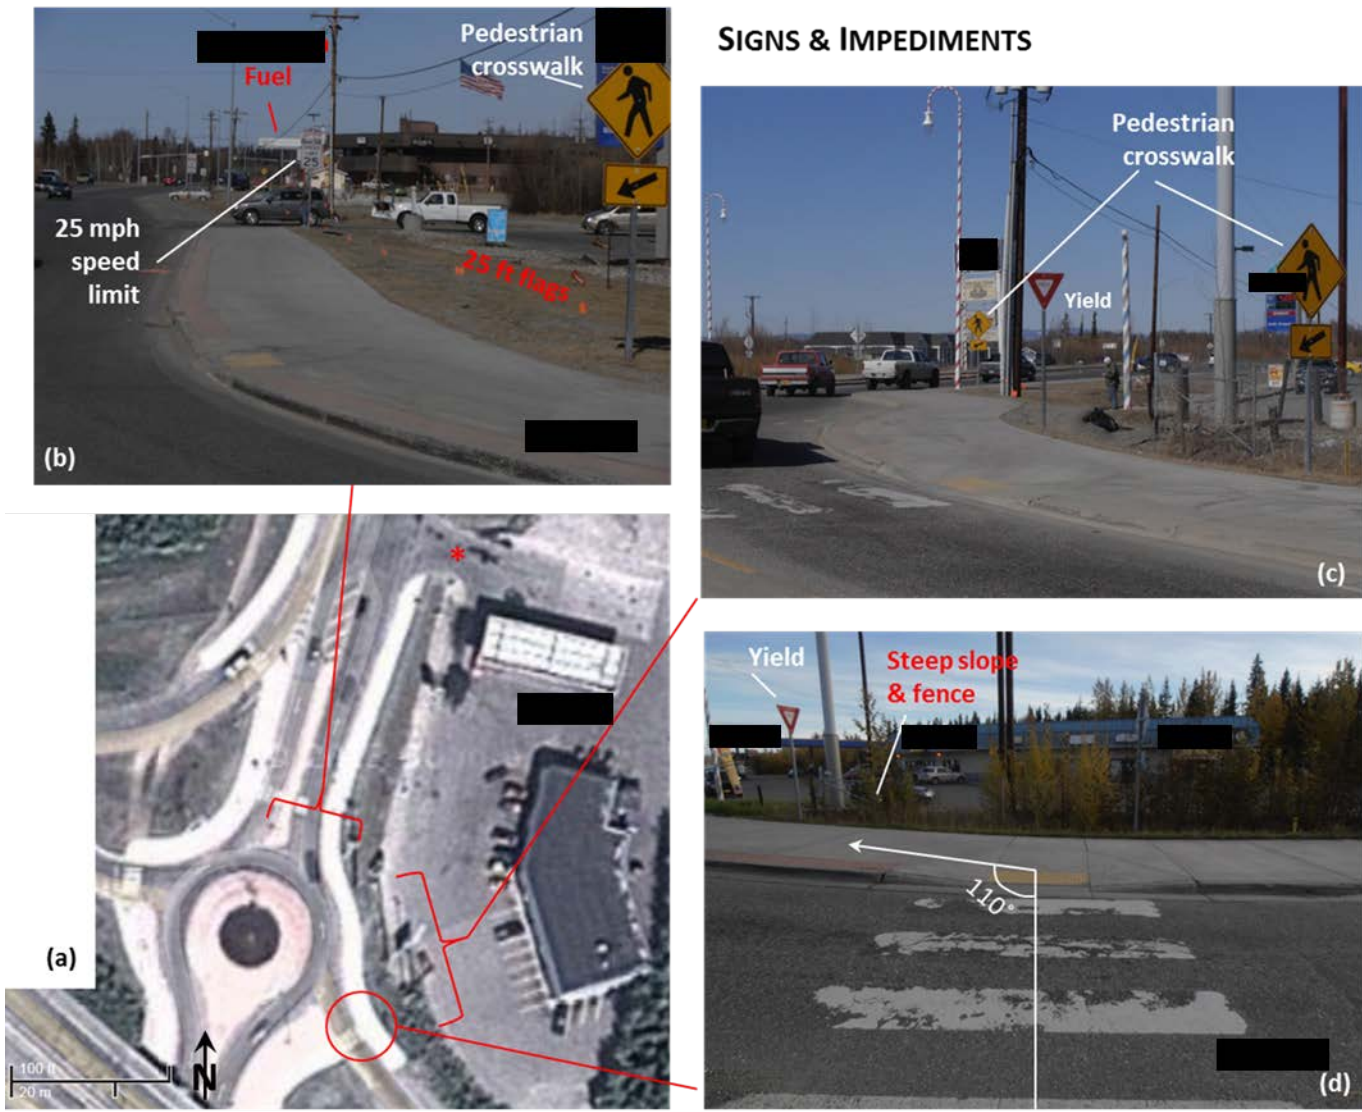
Figure 10. (a) Google base map depicting all approaches to the [redacted] Road roundabout; (b) 25 mph speed limit sign posted at [redacted] driveway; (c) pedestrian and yield signs at crosswalks; and (d) sharp turn at Bicycle Approach crosswalk ([redacted] Hwy off-ramp at right).

The roundabouts are well marked for pedestrians at multiple crosswalks with yield signs, pedestrian crossing signs, and the 25 mph speed limit is posted at the [REDACTED] driveway entrance (Fig. 10). The sidewalk distance from the [REDACTED] off-ramp crosswalk to the [REDACTED] driveway was measured at 268 feet (Fig. 11). Bicycles traveling through this crosswalk must negotiate the approximate 110-degree turn to the left (Fig. 10d) at slow speeds to stay on the sidewalk. We determined through bike-travel simulation that speeds in excess of about 8 mph would send a bicyclist off of the sidewalk and down a steep grassed slope with fence below (Fig. 10d).

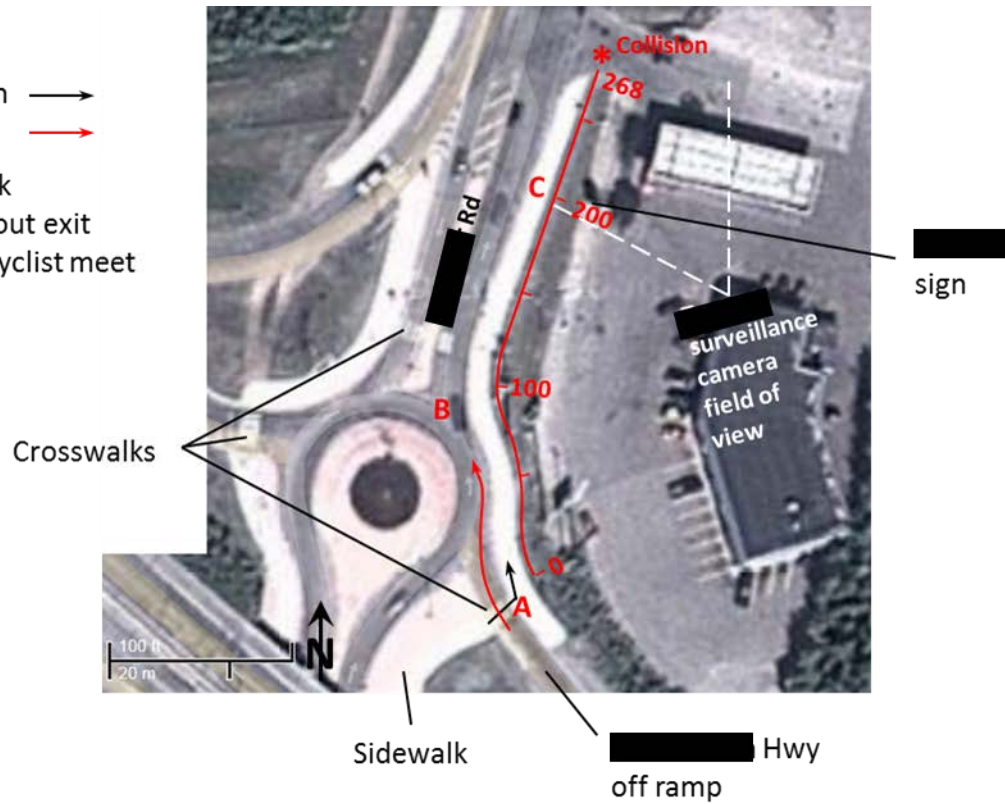
Figure 11. Approach hypothesis: Point A bicycle speed < 8 mph, truck accelerating; Point B, both bicycle and truck accelerating, bicycle catching up to truck; Point C bicycle parallel to truck flatbed rear end.

Referring to Figure 11 (point C vicinity), road traffic approach speeds ranged from 12 to 23 mph (Table 2). Of the 31 vehicles observed over an hour that turned into the [REDACTED] driveway, nearly all had accelerated through the roundabout-to-straightaway transition, and it was apparent that drivers who planned or made early decisions to turn into the [REDACTED] driveway began to slow down and used their turn signals before point C (~75 feet before the driveway). There were six 'late-decision turns', whereby vehicles abruptly slowed and turn signals came on within about 35 feet of the turn. There were four drivers that did not use a turn signal for turning into the driveway.

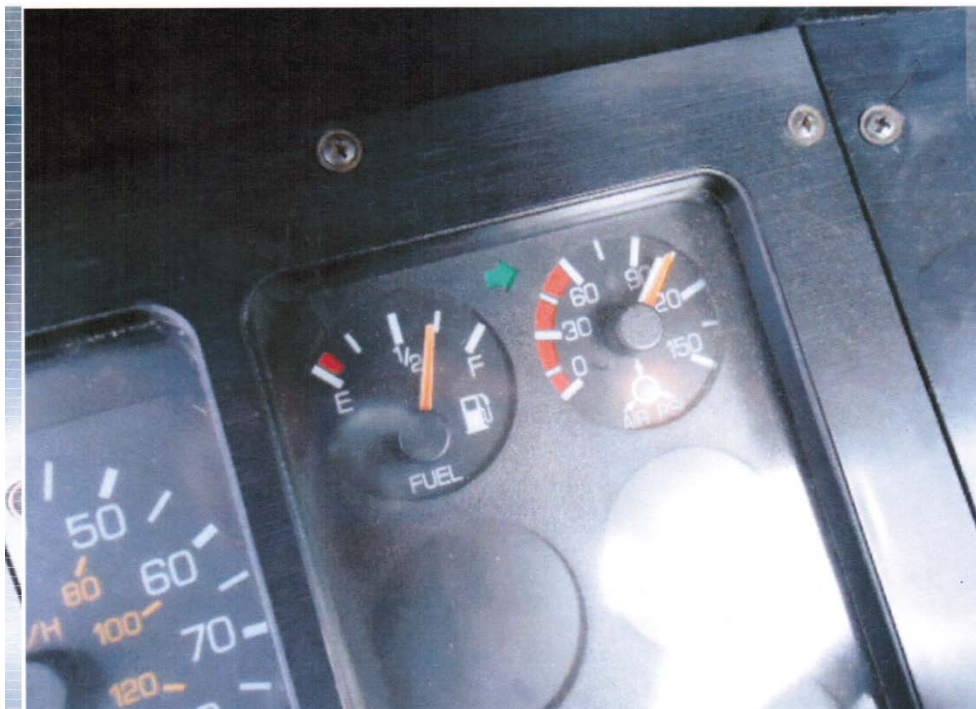
Figure 12. truck fuel gage at the time of collision.

There are two gas station/convenience stores in the vicinity of the accident location: the [REDACTED] and [REDACTED] Fuel. They are located about a tenth-of-a-mile apart and within view of each other. We performed traffic counts by vehicle type on July 25, [REDACTED], from 7:30 to 8:30 am and 5 to 6 pm, to see if there was preference for fueling between the two stations during peak traffic times. Results indicated a preference by all types of vehicle (commercial trucks inclusive) for the [REDACTED], except for long vehicles (e.g., tractor-trailers, 18 wheelers, and cars/trucks towing boats) – [REDACTED] Fuel offers more turn-around room. The price of unleaded fuel was the same at both stations on July 25, but diesel was two cents per gallon cheaper at [REDACTED]. We surmised that location, [REDACTED] being closest to the [REDACTED] Highway, was a dominate factor for overall preference. Further, it is common practice for a company to be contracted with a particular fuel vendor for fueling of their fleet vehicles. We noted one accident scene photograph (Fig. 12) that showed the [REDACTED] truck fuel gage at nearly three-quarters full at the time of the accident. The driver was likely turning into the [REDACTED] plaza for reason other than refueling.
